Report Date 12/17/2007

Company AHI Home Inspection

Thermographer Al Shah

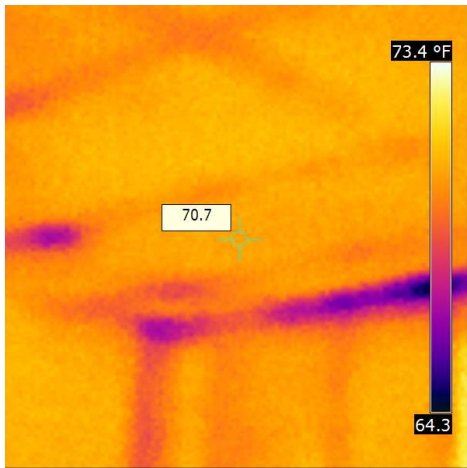
Image and Object Parameters		Text Comments
Camera Model	FLIR B-CAM Western S	
Image Date	2007:12:17 02:46:07	
Image Name	IR_0001.jpg	
Emissivity	0.96	
Reflected Temperature	68.0 °F	
Object Distance	6.6 ft

Description
Master Bedroom East and South walls show signs of air infiltration and poor joints at Vapour barrier
