**Report Date** 12/17/2007

**Company** AHI Home Inspection

**Thermographer** Al Shah

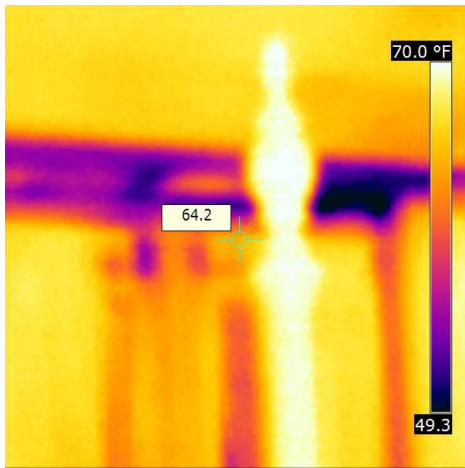
Image and Object Parameters		Text Comments
Camera Model	FLIR B-CAM Western S	
Image Date	2007:12:17 02:48:53	
Image Name	IR_0004.jpg	
Emissivity	0.96	
Reflected Temperature	68.0 °F	
Object Distance	6.6 ft

Description
Front Bedroom. Air infiltration,insulation problems
